Millimeter waves solve a problem of ultrasound-based wall thickness measurements of FRP-components

→ Millimeter wave testing

This flyer discusses results generated using a FMCW-radar in the range 75 GHz - 110 GHz inspecting different FRP test samples.

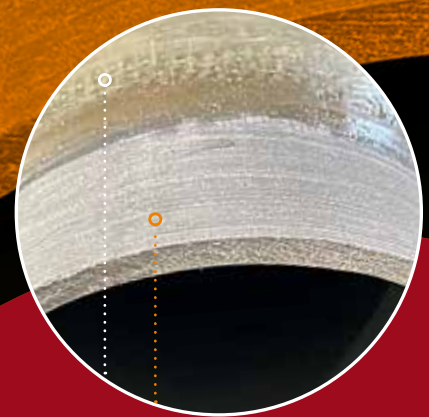
Diffusion barrier / PE-inliner in FRP-pipes ←

Structure:

- typically 3-20 mm FRP-laminate
- several mm PE-inliner

Testing:

- in reflection,
- from the outer side
- during operation!

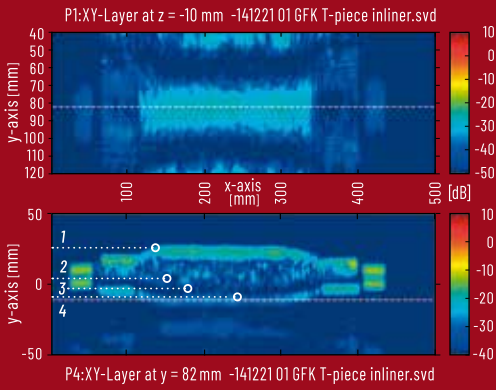
→ C-Scan

showing inside interface between PE-inliner and air (dashed line):
surface echo at z = -10 mm

$$d_{PE} = \frac{10 \text{ mm} - 1 \text{ mm}}{n_{PE} (\approx 1.5)} = 6 \text{ mm}$$

B-Scan

(profile in z-direction) at position see above (dashed line)

1. surface echo (surface FRP-laminate)
2. interface FRP-inliner (PE)
3. PE-volume (fibre free)
4. backwall echo (inside surface PE-inliner)

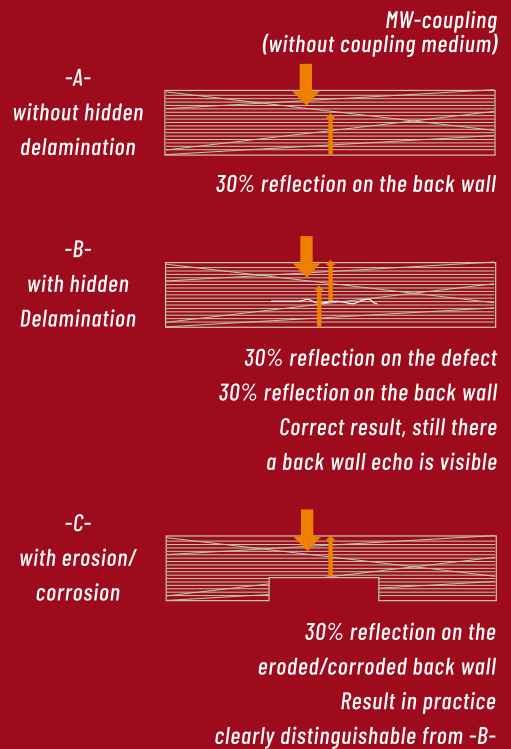
Physical solution

with MW testing: FRP wall thickness measurement, e.g. at 100 GHz

Since the refractive index in the millimeter range for FRP (appr. 2.0) and air (appr. 1.0) is similar you see a reflectivity of only 30% in case of a delamination. Therefore, millimeter waves propagate beyond such a delamination and a backwall echo can still be detected. This way you can distinguish between a delamination and a wall thickness degradation caused by corrosion or erosion.
